# **Inspection Report**

Property Address: 145 Easy St. Somewhere CO

Date: 8/7/2015 Time: 10:00 AM Report ID: 15-807-1

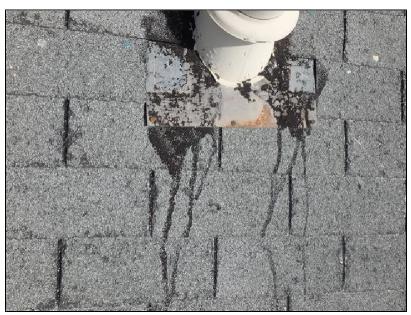
1.1 Item 1(Picture)

1.1 The metal flashing is mastic covered, monitor this area periodically for possible leaks at most vent type flashings rear side of home.

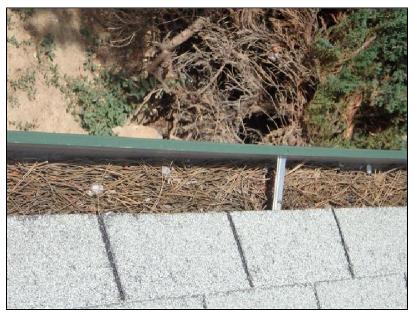
1.4 Item 1(Picture)

1.4 (1) The gutters are full of debris in areas and needs to be cleaned. The debris in gutters can also conceal rust, deterioration or leaks that are not visible until cleaned, and I am unable to determine if such conditions exist.

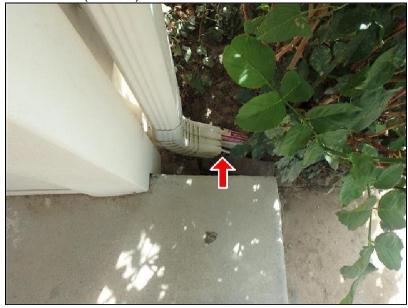
# 1.4 Item 2(Picture)

# 1.4 (3) Downspout extensions damaged.

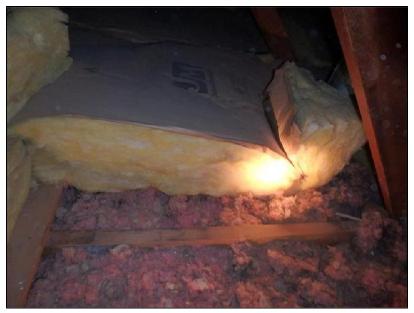
1.6 Item 1(Picture)

1.6 (1) Fiberglass (Batts) insulation is installed with "paper or kraft" face up. The paper side should always face the "heated space" or condensation could occur, installed incorrectly on top of existing loose fill insulation, and not spread out evenly in attic. Heat loss can occur more on this home than one that is properly insulated. A qualified contractor should inspect and repair as needed.

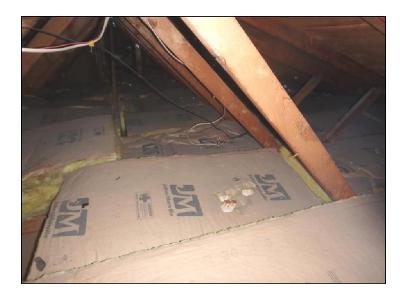
#### 1.6 Item 3(Picture)

1.6 (2) Fiberglass Batt Insulation is about twelve inches thick or 38.4 R value.

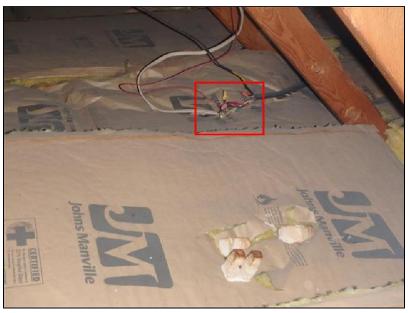
1.7 Item 1(Picture)

1.7 Two loose wire splices needs placing inside a box with a cover-plate in attic in attic. This is a safety issue that needs to be corrected. I recommend a qualified licensed electrician correct.

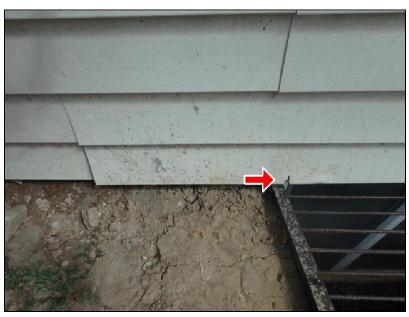
2.0 Item 1(Picture)

2.0 (1) The Vinyl siding at the front of home is damaged. This is a cosmetic issue,. A qualified contractor should inspect and repair as needed.

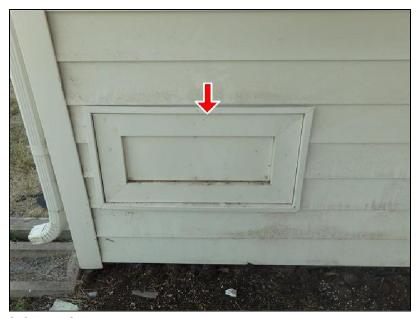
2.0 Item 2(Picture)

2.0 (2) The Vinyl siding at the (West side of home) has a access cut into it. This is for your information. I recommend repair as desired.

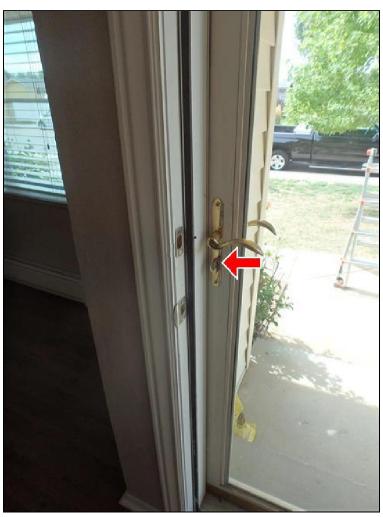
2.1 Item 1(Picture)

2.1 (2) The storm door at the front entry door rubs at porch cover when opened. This is for your replacement is needed. A qualified person should repair or replace as needed.

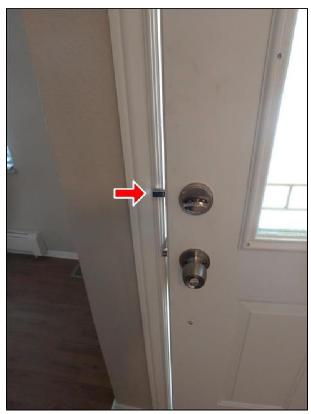
2.1 Item 3(Picture)

2.1 (3) The front entry door dead bolt won't lock needs adjustment. This is a small repair. A qualified person should repair or replace as needed.

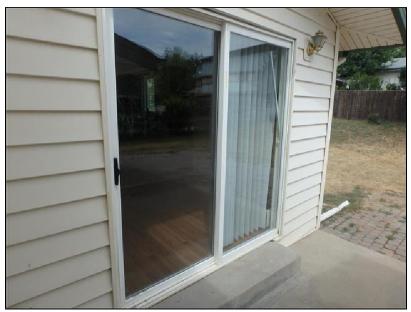
2.1 Item 4(Picture)

2.1 (4) The sliding screen doors are missing. A replacement is needed. A qualified person should repair or replace as needed.

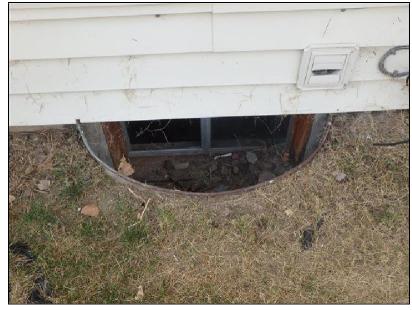
2.2 Item 1(Picture)

2.2 Recommend window covers for basement windows.

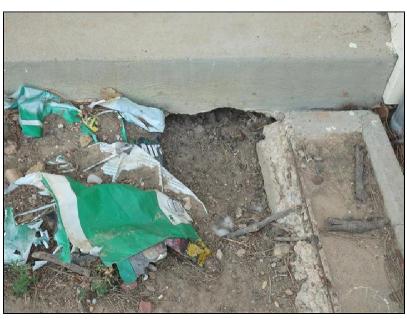
2.3 Item 1(Picture)

2.3 The concrete patio on the rear entry bedroom at the rear of home soil has eroded leaving a gap. Pests could enter if not corrected . I recommend back filling.

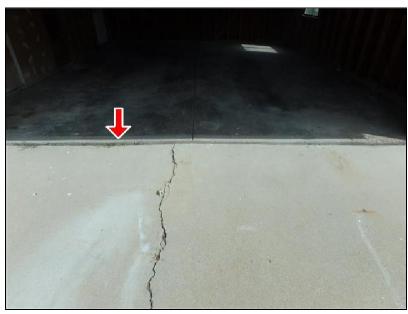
2.4 Item 1(Picture)

2.4 (1) The concrete drive at the front of home has settlement cracks, and has settled, causing a tripping hazard. Water can cause further deterioration if not repaired and sealed properly, A fall or injury can occur if not corrected. A qualified contractor should inspect and repair as needed.

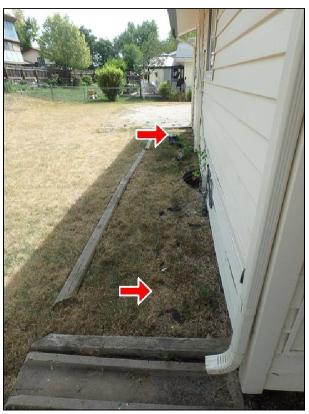
2.4 Item 9(Picture)

2.4 (5) There is a negative slope towards the rear of home. This area does not appear to drain water away from home and needs landscaping and drainage corrected.

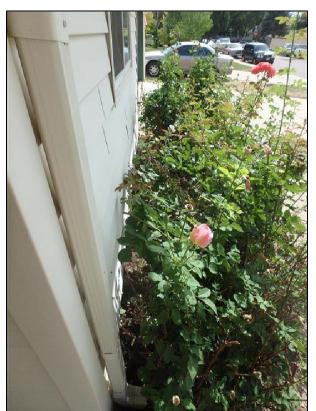
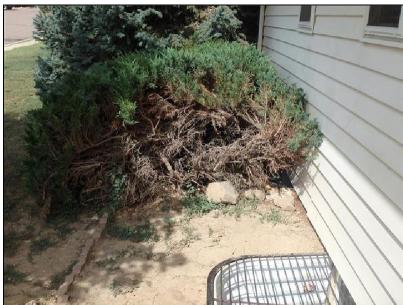
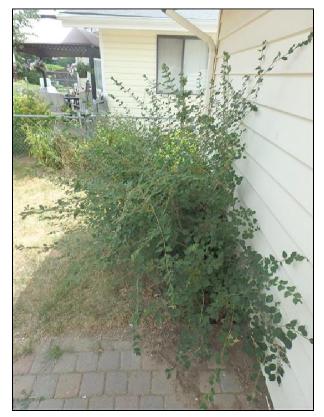
2.4 (6) Plants touching house, should be trimmed away to prevent damage to siding.

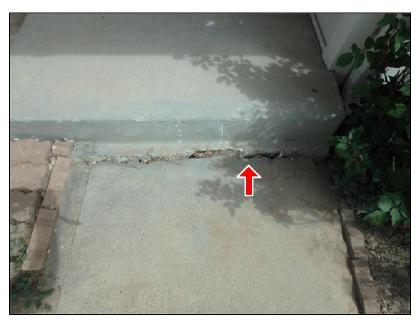
2.4 Item 13(Picture)

2.4 (7) The concrete walkway at the front of home has settled leaving a gap from the walkway to the porch. Further deterioration can occur if not repaired. A qualified contractor should inspect and repair as needed.

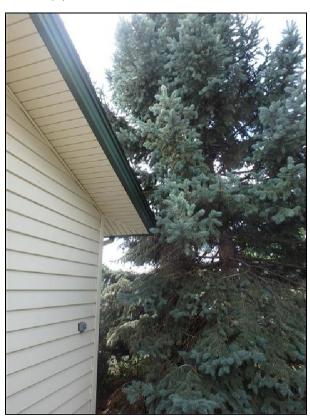
2.4 Item 14(Picture)

2.4 (8) The tree limbs that are in contact with roof or hanging near roof should be trimmed.

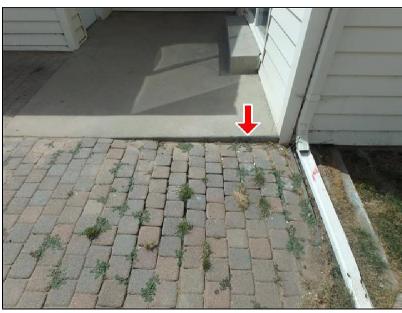
2.4 Item 15(Picture)

2.4 (9) The paver block patio at the rear of home has settled, causing a tripping hazard. A fall or injury can occur if not corrected. This is for your information..

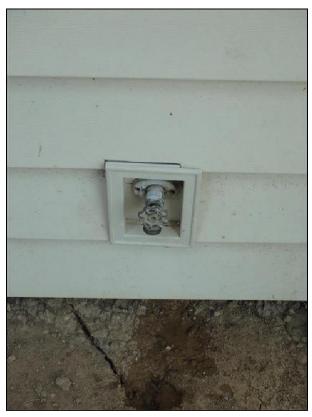
2.6 Item 1(Picture)

**2.6** The hose bib is not a freeze protected type at the front of home. If water is left in pipe it could freeze at low temperatures. I recommend a licensed plumber inspect further and repair as necessary.

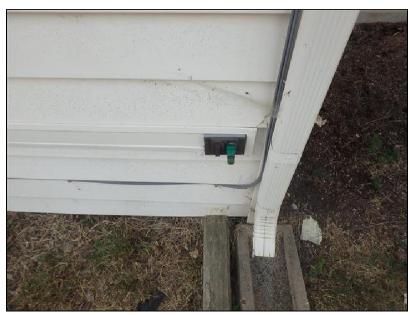
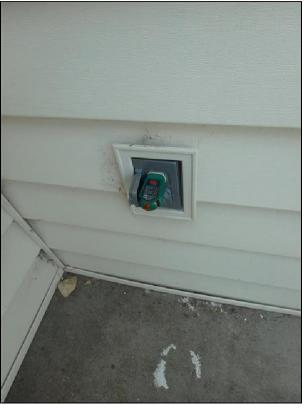
2.7 (1) Exterior outlets are not GFCI type outlets. I recommend replacing them with GFCI type outlets for safety.

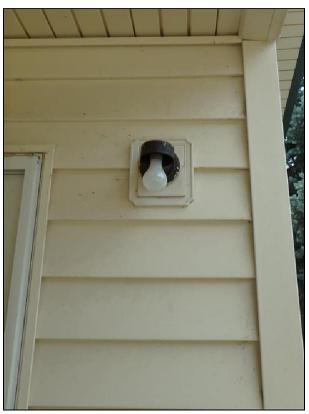
2.7 Item 3(Picture)

2.7 (2) The light fixture is missing globe at the rear entry door at bedroom. A replacement is needed. This is for your information.

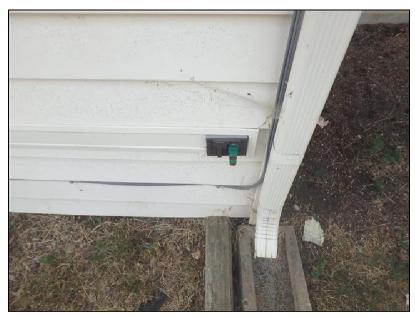
2.7 Item 4(Picture)

2.7 (3) The exterior outlet at the rear of home has a damaged cover plate. This is a safety issue that needs to be corrected. I recommend repair as needed.

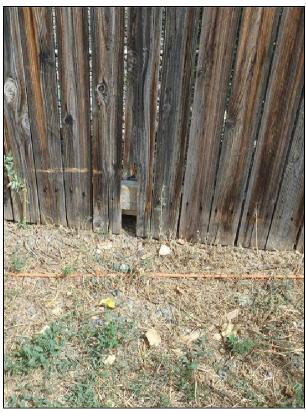
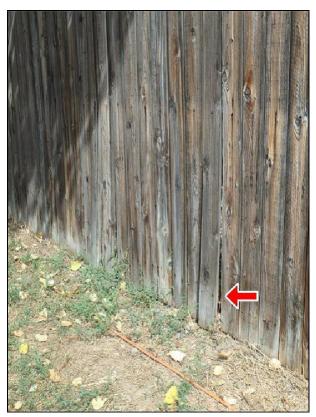
2.8 Wood fence has loose posts, has loose boards, and has broken boards back yard

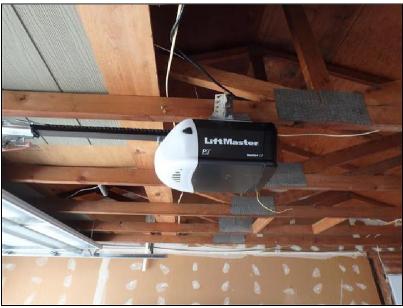
3.3 Item 1(Picture)

**3.3** The automatic opener for garage door at the front of home will not reverse when met with resistance, this could cause a injury to a person or a pet. This is considered unsafe and needs correcting. A qualified contractor should inspect and repair as needed.

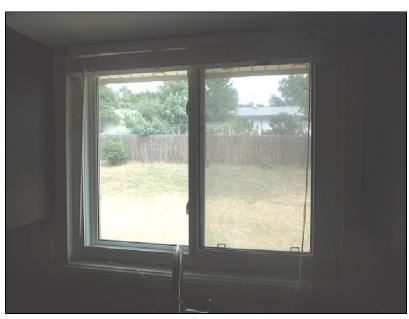
4.4 Item 1(Picture)

**4.4** One window screen damaged at the kitchen. A replacement is needed . A qualified person should repair or replace as needed.

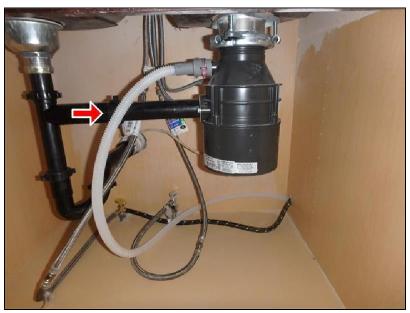
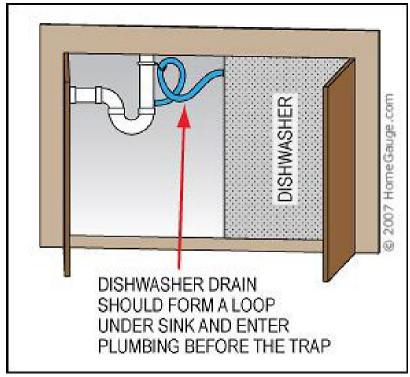
4.9 The dishwasher drain hose did not perform a loop to create a trap under sink. I recommend repair as necessary.

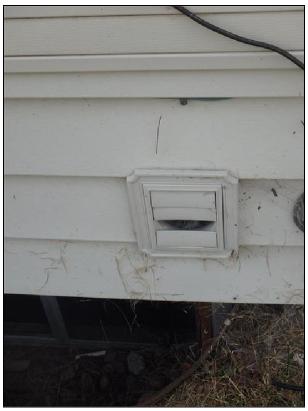
4.15 Item 1(Picture)

4.15 Dryer vent cover at exterior is damaged. Needs repair or replacement.

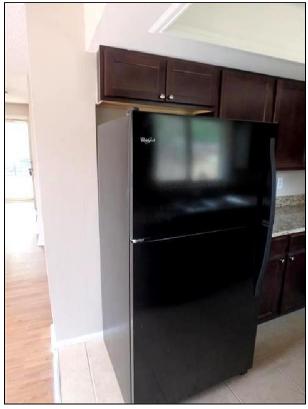
4.16 Item 1(Picture)

4.16 (1) The frigerator is not the proper size for intended location. This is for your information.

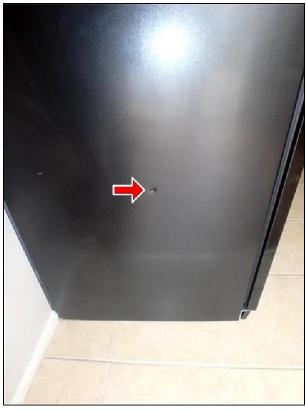
4.16 Item 2(Picture)

4.16 (2) Refrigerator damaged. this is a cosmetic issue.

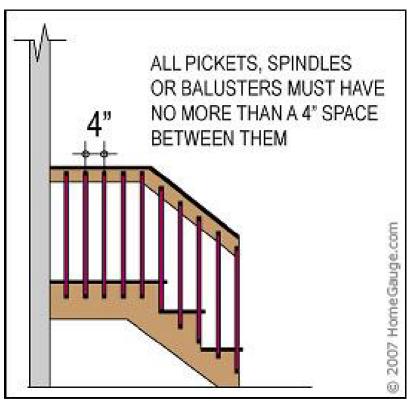
5.2 Item 1(Picture)

**5.2** (1) The hand/guard rail for the basement stairs pickets are spaced over 4" apart. A fall or injury could occur if not corrected. This is for your information.

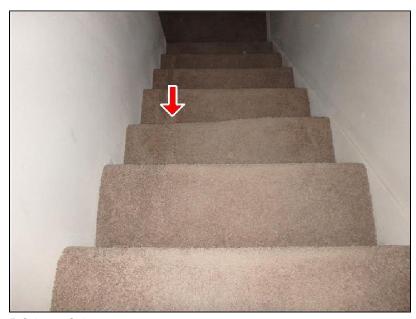
5.2 Item 2(Picture)

**5.2** (2) Basement stairs to basement is damaged. A fall or injury could occur if not corrected. A qualified person should repair or replace as needed.

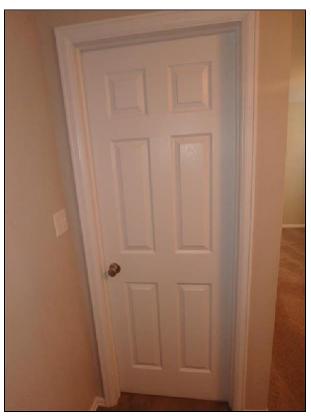
5.4 Item 1(Picture)

5.4 The interior door rubs at jamb when closing at the downstairs bedroom(s). A repair or replacement is needed. A qualified person should repair or replace as needed.

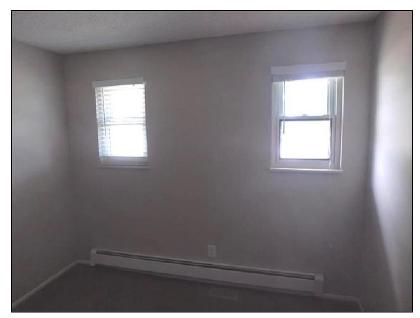
5.5 Item 1(Picture)

5.5 (1) Two windows is not a proper egress window at the bedroom(s). This is a safety issue. This is for your information..

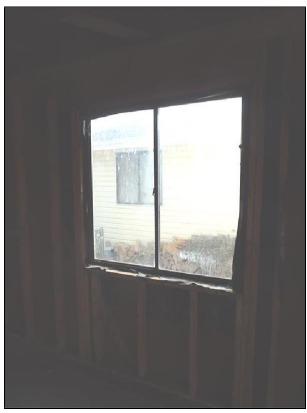
5.5 Item 2(Picture)

**5.5** (2) One window cloudy (lost seal), and missing screen at the garage. In order to correct the cloudy appearance of glass, a replacement of glass pane or the unit will be necessary. A qualified contractor should inspect and repair as needed.

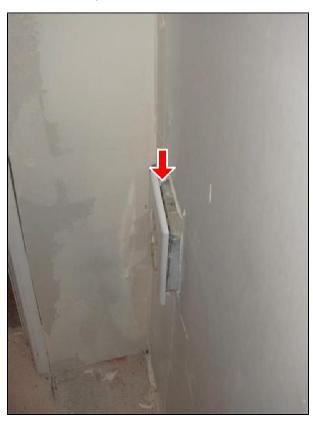
5.6 Item 4(Picture)

**5.6** (2) One "three-prong" outlet is loose in wall in basement. This is a safety issue that needs to be corrected. A qualified licensed electrician should correct as needed.

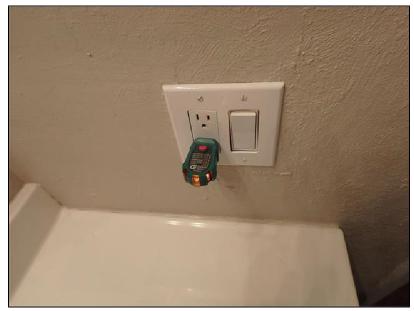
6.5.A Item 1(Picture)

**6.5.A** One "three-prong" outlet is outdated and not a three-prong GFCI (Ground Fault Circuit Interrupt) type outlet main level hall bath. This is a safety issue that needs to be corrected. A qualified licensed electrician should correct as needed.

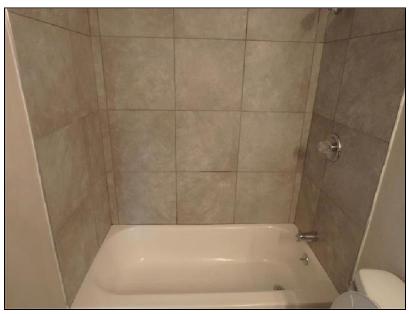
6.7.A Item 1(Picture)

**6.7.A** The Tile surround at bathtub on the wall needs caulking at tub to wall, needs caulking tub to floor, and corners at the main level hall bath. This is a small repair issue for your information. A qualified person should repair or replace as needed.

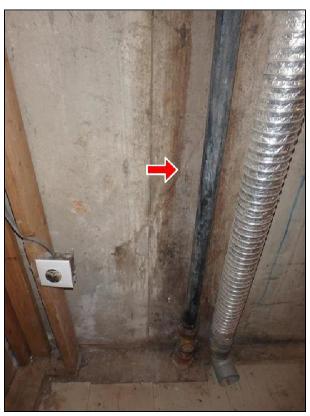
7.0 Item 1(Picture)

7.0 (1) The Typical settlement crack(s) in the foundation wall at the rear of home. This crack does not appear significant to require repairs at this time. I recommend sealing crack with a suitable material.

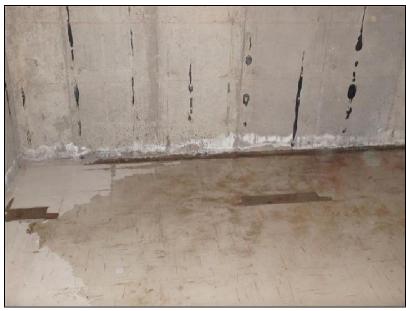
7.0 Item 2(Picture)

**7.0** (2) White efflorescence (powder substance) on foundation wall indicates moisture is in contact with the masonry. This does not necessarily indicate that intrusion will occur. I recommend checking the gutters and the downspout drain lines for proper operation. Also, a water proofing paint could be applied to the interior side of the foundation if necessary. Efflorescence is found on many homes without water intrusion occurring inside the home. But, it should alert you to the possibility that future steps may be needed.

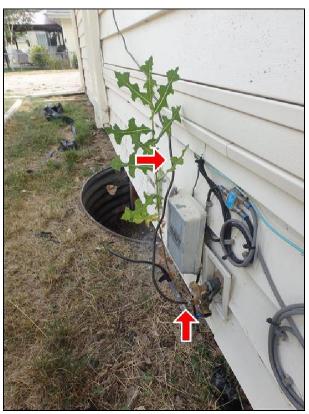
8.1 Item 1(Picture)

**8.1** The saddle valve, and copper supply line is not being used, should be removed at the exterior north wall. This is for your information. I recommend a licensed plumber inspect further and repair as necessary.

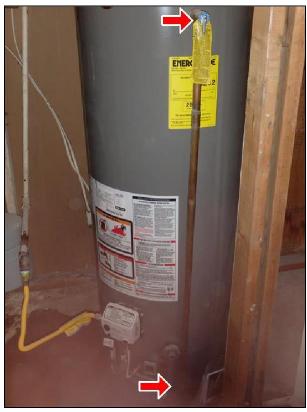
8.2 Item 1(Picture)

**8.2** (1) The water heater is leaking at the "TPR" valve. A more thorough inspection by a qualified contractor is needed. A qualified licensed plumber should repair or correct as needed.

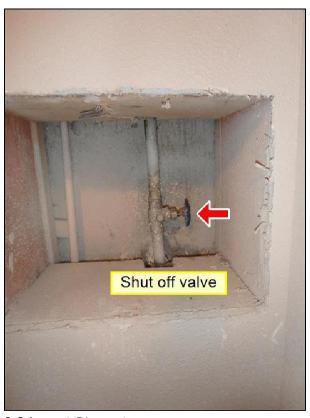
8.3 Item 1(Picture)

No pressure regulator installed

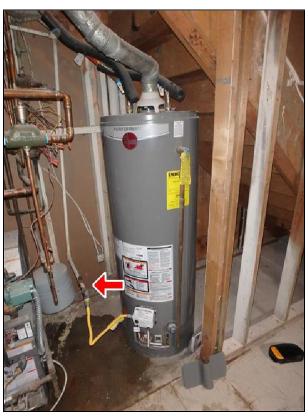
8.4 Item 1(Picture)

**8.4** The gas line has no drip leg installed at the water heater. This is for your information. A qualified contractor should inspect and repair as needed

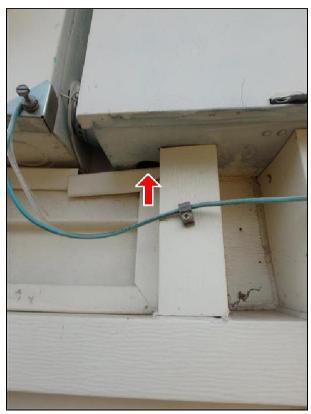
9.1 Item 1(Picture)

9.1 (1) The main panel box is located at the outside north wall. The panel missing wire feed knockout. This is a safety issue that needs to be corrected. A qualified licensed electrician should correct as needed.

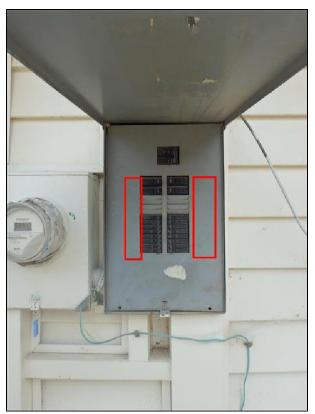
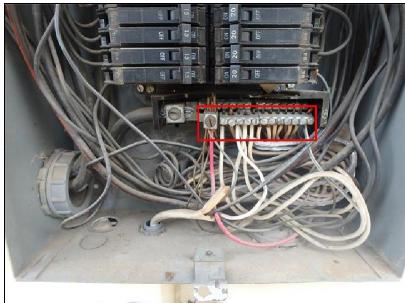
9.1 (2) The problem(s) discovered in the panel such as two or more neutrals on the same lug, circuits not labeled or identified, double tapped breaker, and red colored ground conductor and any other problems that an electrician may discover while performing repairs need correcting. I recommend a licensed electrician inspect further and correct as needed.

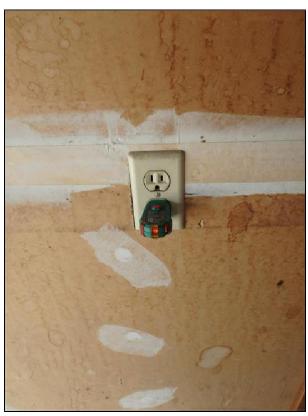
9.4 Item 1(Picture)

**9.4** The three prong outlet(s) at the Garage is not a GFCI type outlet. This is a safety issue that needs to be corrected. A qualified licensed electrician should correct as needed.

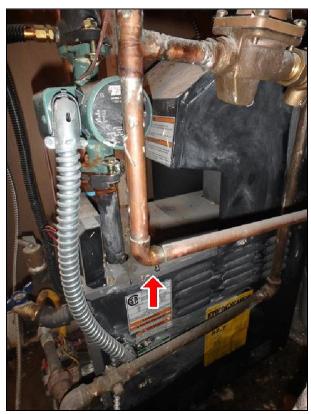
10.0 Item 1(Picture)

10.0 (1) The gas-fired boiler is leaking at water supply pipe. Leaks can cause damage to unit or home. A qualified HVAC person should inspect further and repair or replace as needed.

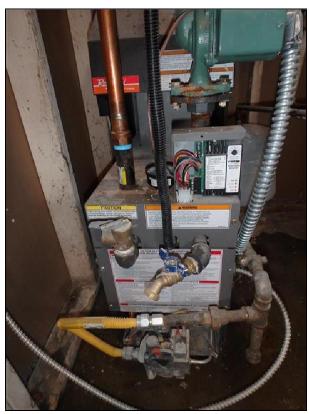
10.0 Item 2(Picture)

10.0 (2) 90,000 BTU boiler dose not appear to have been serviced within the last year, dirty. I recommend having a licensed contractor service and certify the furnace.

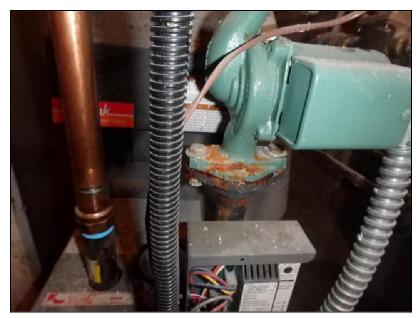
10.0 Item 3(Picture)

10.0 (3) The gas-fired boiler rust and corrosion present. A more thorough inspection by a qualified contractor is needed. A licensed HVAC contractor should service or repair unit.

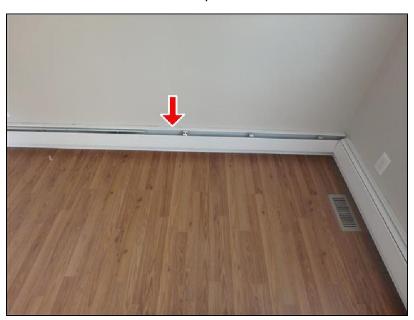
10.3 Item 1(Picture)

10.3 (1) The wall convector is damaged at the living room. This is a cosmetic issue. A licensed HVAC contractor should service or repair unit.

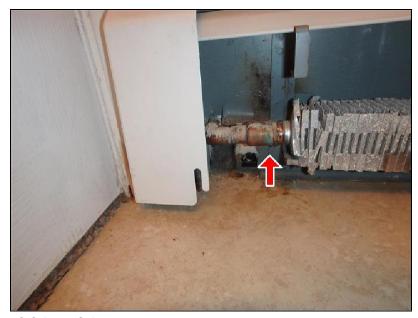
10.3 Item 2(Picture)

10.3 (2) The supply piping from boiler at wall convector in main level bath is leaking. Repairs needed. A qualified HVAC person should inspect further and repair or replace as needed.

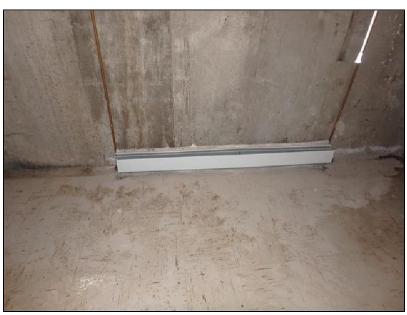
10.3 Item 3(Picture)

10.3 (3) The wall convectors did not work in basement. Repairs needed. A qualified HVAC person should inspect further and repair or replace as needed.

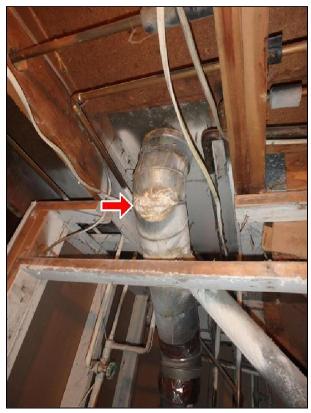
10.5 Item 1(Picture)

10.5 The vent pipe for gas-fired boiler shows evidence of poor venting (white deposits, rust on piping). A more thorough inspection by a qualified contractor is needed. I recommend a qualified licensed heat contractor inspect further and repair as needed.
