# **Inspection Report**

Property Address: 145 Easy St. Somewhere CO

Date: 8/7/2015 Time: 10:00 AM Report ID: 15-807-1

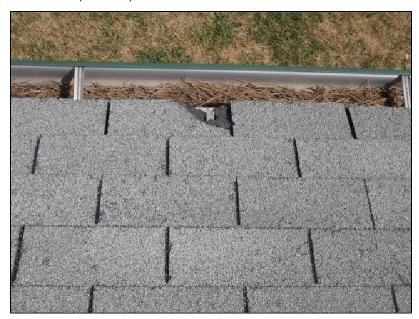
1.1 Item 2(Picture)

1.1 The metal flashing is mastic covered, monitor this area periodically for possible leaks at most vent type flashings rear side of home.

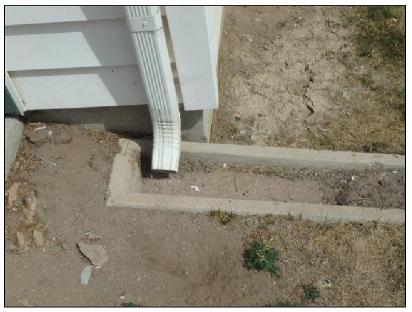
1.4 Item 3(Picture)

# 1.4 (3) Downspout extensions damaged.

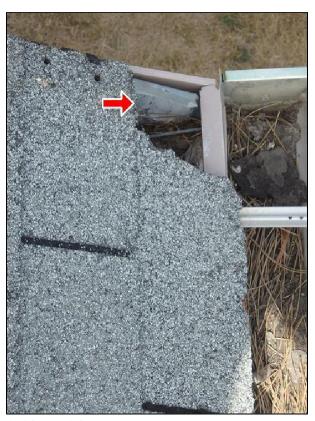
1.5 (1) The plywood sheathing is damaged west side of attic. The roof sheathing needs to be replaced in this area. This will involve some shingle replacement. A qualified contractor should inspect and repair if needed..

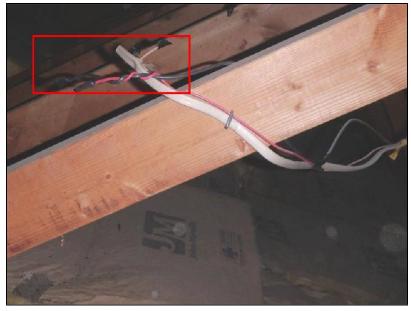
1.7 Two loose wire splices needs placing inside a box with a cover-plate in attic in attic. This is a safety issue that needs to be corrected. I recommend a qualified licensed electrician correct.

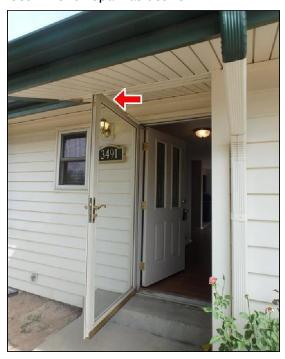
2.1 (1) The storm door at the front entry door Dead bolt needs adjustment to lock. A repair or information.. I recommend repair as desire

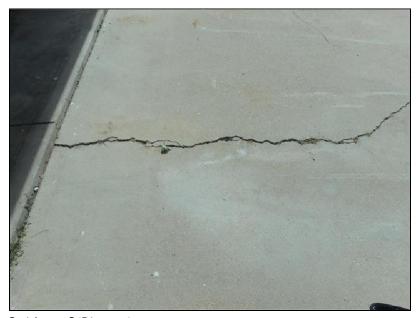
2.4 Item 2(Picture)

2.4 (1) The concrete drive at the front of home has settlement cracks, and has settled, causing a tripping hazard. Water can cause further deterioration if not repaired and sealed properly, A fall or injury can occur if not corrected. A qualified contractor should inspect and repair as needed.

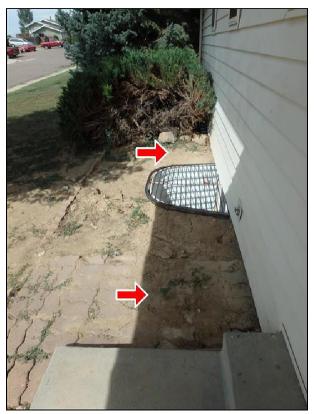
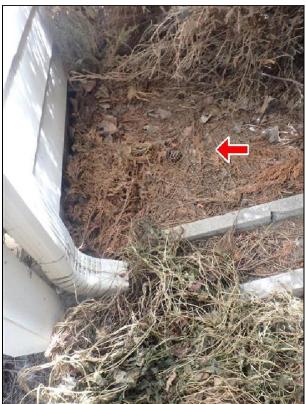
2.4 (2) There is a negative slope towards the front of home. This area does not appear to drain water away from home and needs landscaping and drainage corrected.

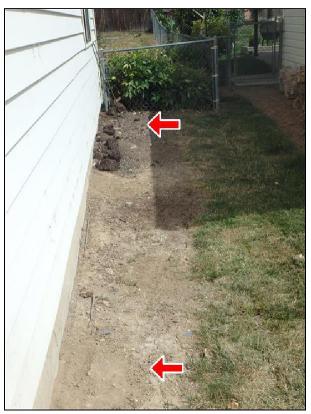
2.4 Item 7(Picture)

2.4 (3) There is a negative slope towards the (East side of home). This area does not appear to drain water away from home and needs landscaping and drainage corrected.

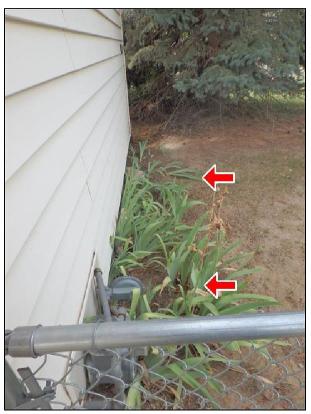
2.4 Item 8(Picture)

2.4 (4) There is a negative slope towards the (West side of home). This area does not appear to drain water away from home and needs landscaping and drainage corrected.

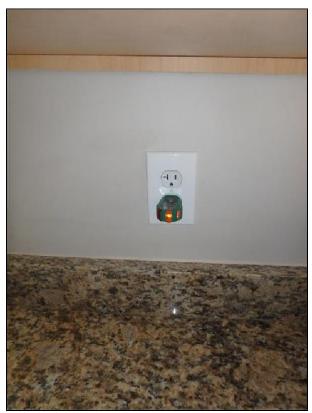
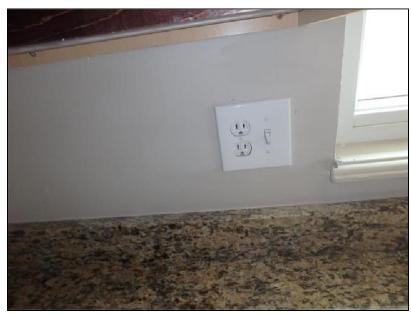
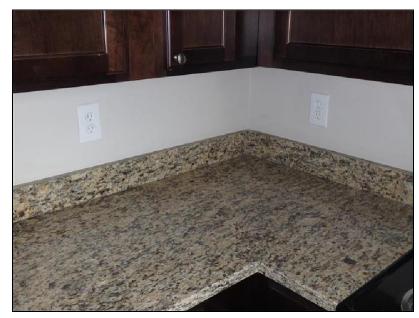
4.8 Four "three-prong" outlets are outdated and not a three-prong GFCI (Ground Fault Circuit Interrupt) type outlet at the kitchen. This is a safety issue that needs to be corrected. A qualified licensed electrician should correct as needed.

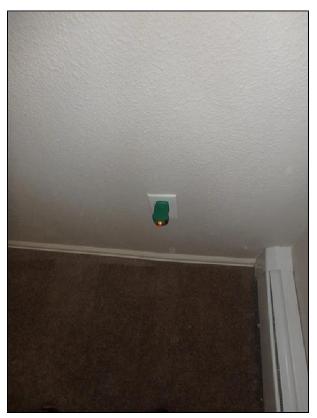
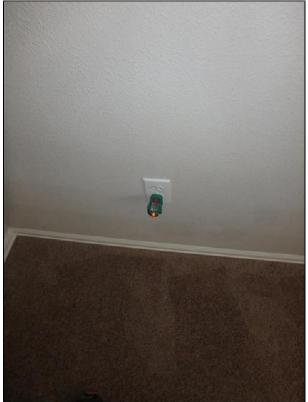
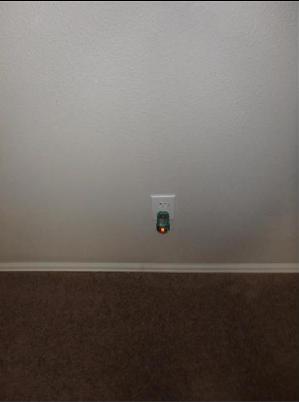
**5.6** (1) A few "three-prong" outlets are not grounded downstairs in bedroom(s). This is a safety issue that needs to be corrected. A qualified licensed electrician should correct as needed.

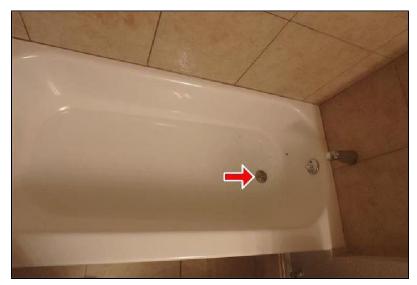
6.3.B Item 1(Picture)

**6.3.B** (1) The stop-valve does not work properly at the downstairs bath tub. Repairs are needed. A qualified licensed plumber should repair or correct as needed.

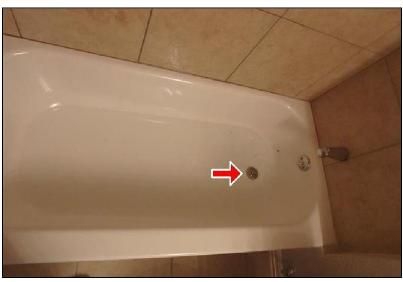
6.3.B Item 2(Picture)

**6.3.B** (2) The plumbing waste line drains slowly at the downstairs bath tub. Repairs are needed. A qualified licensed plumber should repair or correct as needed.

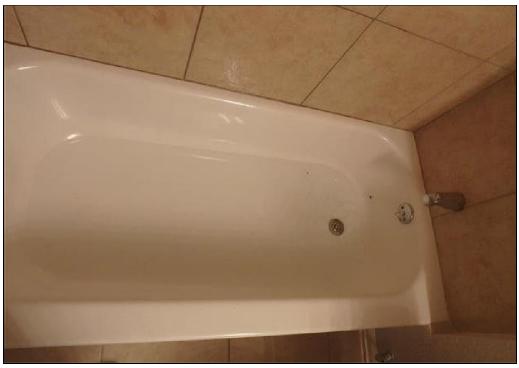
6.7.B Item 1(Picture)

- **6.6.B** No ventilation (window or exhaust fan) for downstairs bath. Normally an exhaust fan or a window is needed for proper ventilation. I did not inspect to determine what steps are needed to comply. I recommend repair as desired.
- **6.7.B** The Tile surround at bathtub on the wall needs caulking at tub to wall, needs caulking tub to floor, and corners at the downstairs bath. This is a small repair issue for your information. A qualified person should repair or replace as needed.

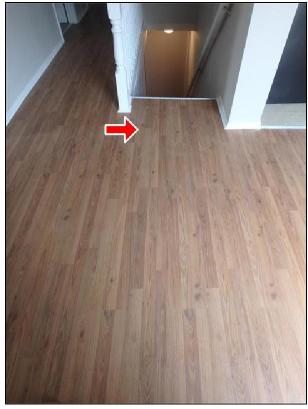
- 7.1 Not able to see concrete foundation walls in basement due to walls being finished.
- 7.2 Couldn't see columns and support posts due to finished walls and ceiling in basement.
- 7.3 (1) Floor seems to have excessive deflection in areas. Though opinions vary I recommend a structural engineer to inspect and repair as needed.

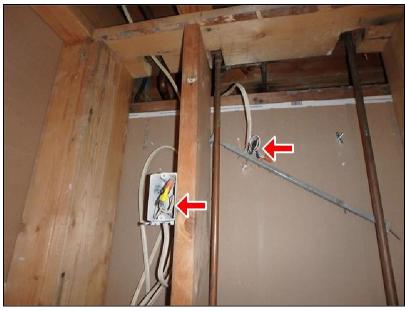
9.3 Item 1(Picture)

9.3 A few open splices needs placing inside a box with a cover-plate in the basement. A qualified licensed electrician should correct as needed.
